Inspection Crawler Crane		www.mevas.eu

Customer:	DEL BONO & CO s.a	vers 11/12	
Date:	18 February 2014		
Machine / type:	Liebherr HS875HD	Hour reading:	7253
Serial No.:	185183	Year:	2008
Inspector:	Gyimesi	boom length:	30
CE <input checked="" type="checkbox"/>	air con <input checked="" type="checkbox"/>	boom check valve <input type="checkbox"/>	
auto lube <input checked="" type="checkbox"/>	jib <input type="checkbox"/>	secondary winch <input checked="" type="checkbox"/>	
cab		cab door	Good (& sliding is OK)
seat	Fair -burnhole on	windows	Good
switches	Good	wipers	Good
gauges	Good	covers/insulation	Good
heater	Good	floor mat	Good
air conditioner	Good	cab structure	Good
engine	(1)	manufacturer	Liebherr D9508
leaks	Good - none seen	serial no.	2007 14 0517
oil condition	Good	blow by	Good
coolant condition	Good	belts	Good
exhaust	Good	alternator	Good
coolers	Poor (1)	smoke	Good
visual inspection exterior		boom	Good

Sample Report

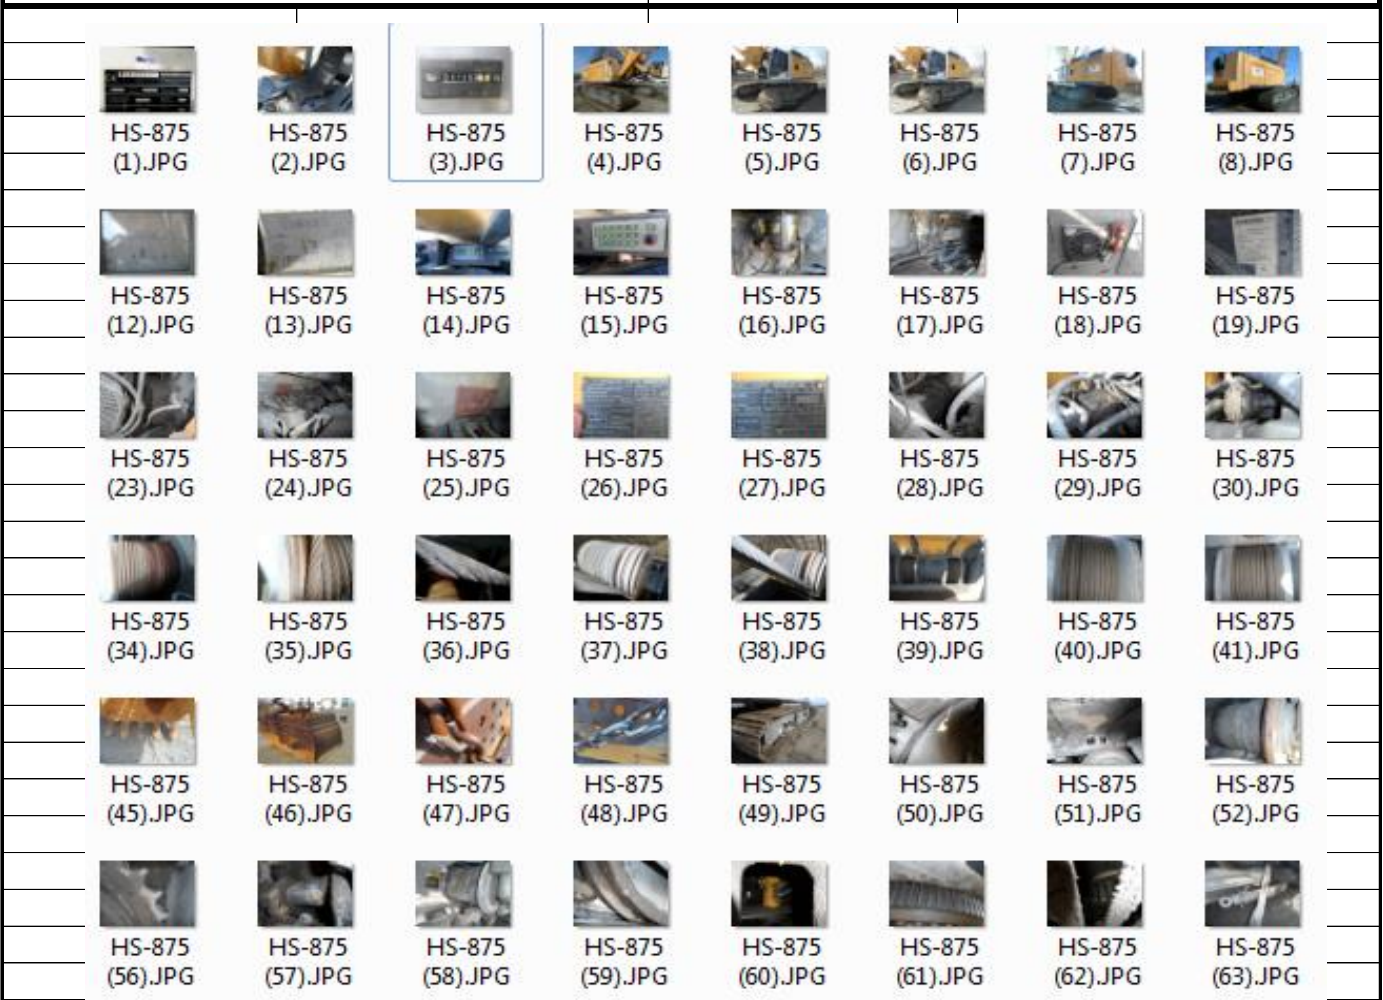
(1) The dataplate is removed from the engine, but available. One cooler has oil residue, but it seems, it comes from the fan motor.
Drag rope limiters (for the motor) seem to be OK. The main engine seems to be a bit worn, but no broken elements, only valves etc. are OK. Condition of the track is OK. See pictures.

The hydraulic pumps have noticeable wet oil residue on, see pictures.
