Evaluation Tracked Excavator		<a href="http://www.mevas.eu">www.mevas.eu</a>

Customer/location:	<i>Mantruc</i>	vers 10/12	
Date:	<i>17/12/2013</i>		
Machine / type:	<i>CAT 325CLN</i>	Hour reading:	<i>stopped at 8686</i>
Serial No.:	<i>CSJ00405</i>	Year:	<i>2002</i>
Inspector:	<i>Mevas 12</i>	stick length:	<i>3.2m</i>
CE <input checked="" type="checkbox"/>	air con <input checked="" type="checkbox"/>	boom check valve	<input checked="" type="checkbox"/>
auto lube <input type="checkbox"/>	stick check valve <input type="checkbox"/>	boom variable <input type="checkbox"/>	Parts book <input type="checkbox"/> Op-Manual <input type="checkbox"/>
blade <input type="checkbox"/>	auxiliary lines <input checked="" type="checkbox"/>	quick coupler type:	
<b>cab</b>		cab door	<i>good</i>
seat	<i>cover is worn through</i>	windows	<i>good</i>
switches	<i>good</i>	wipers	<i>good</i>
gauges	<i>SMU is not working</i>	floor mats	<i>good</i>

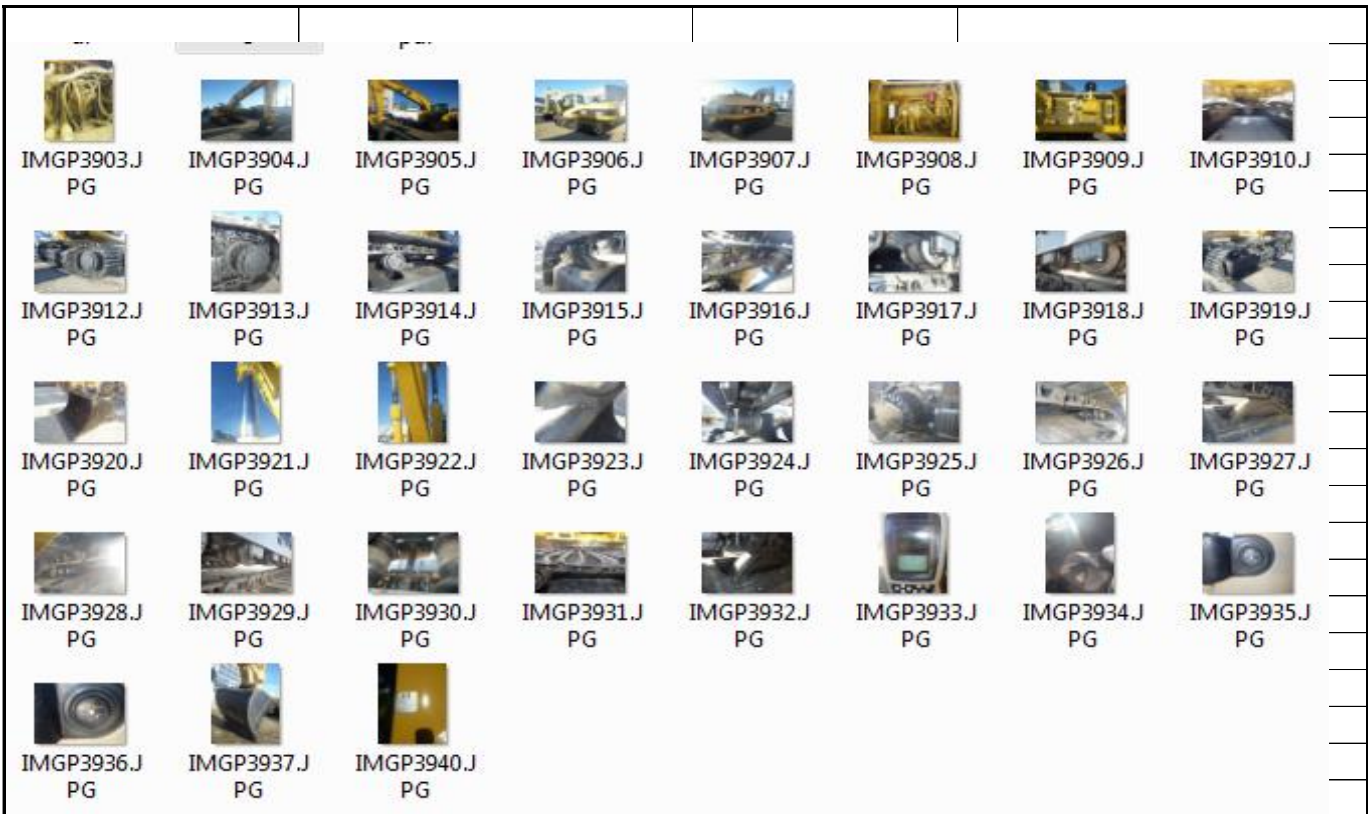
<i>The general machine condition is good. Repaint has been done over all components including hydraulic hoses and alternator.</i>			
dimensions for transport L x W x H in meter:	<i>11m x 3.2m x 3.3m</i>
