Evaluation Wheel Loader

machine / type: CAT 938G inspector: W.Gerber

Serial No.: 6WS03157 year: 2004 hour reading: 11548

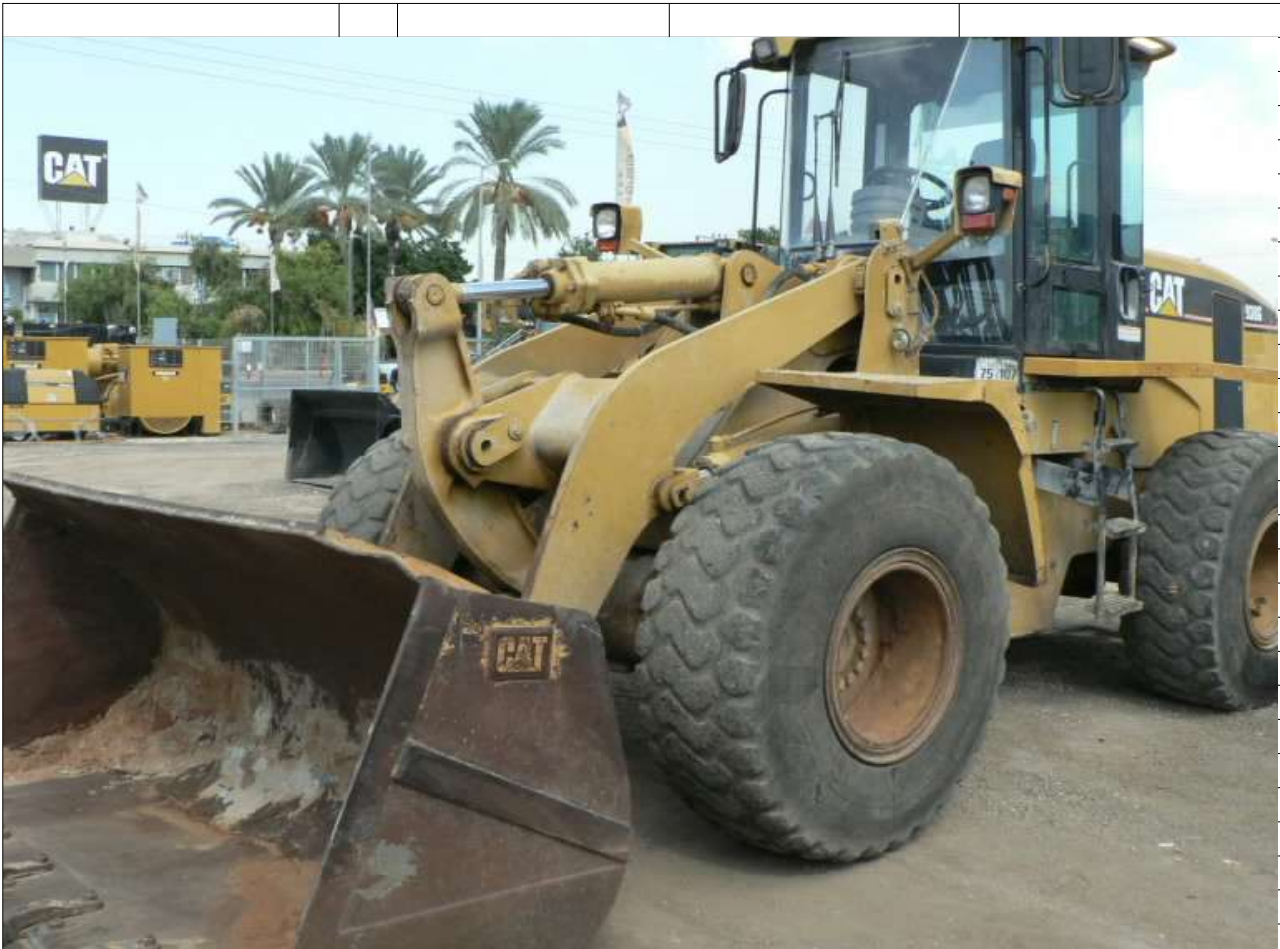
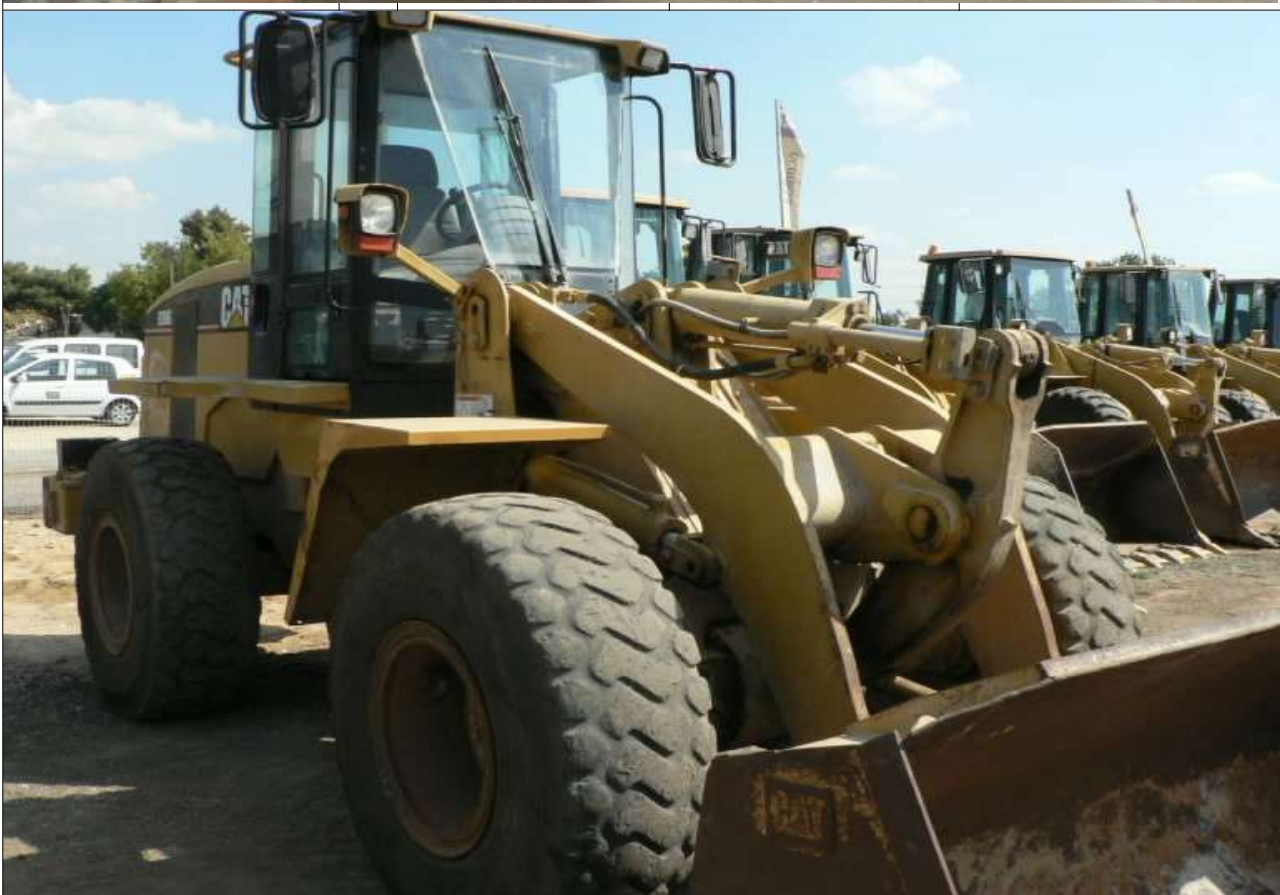
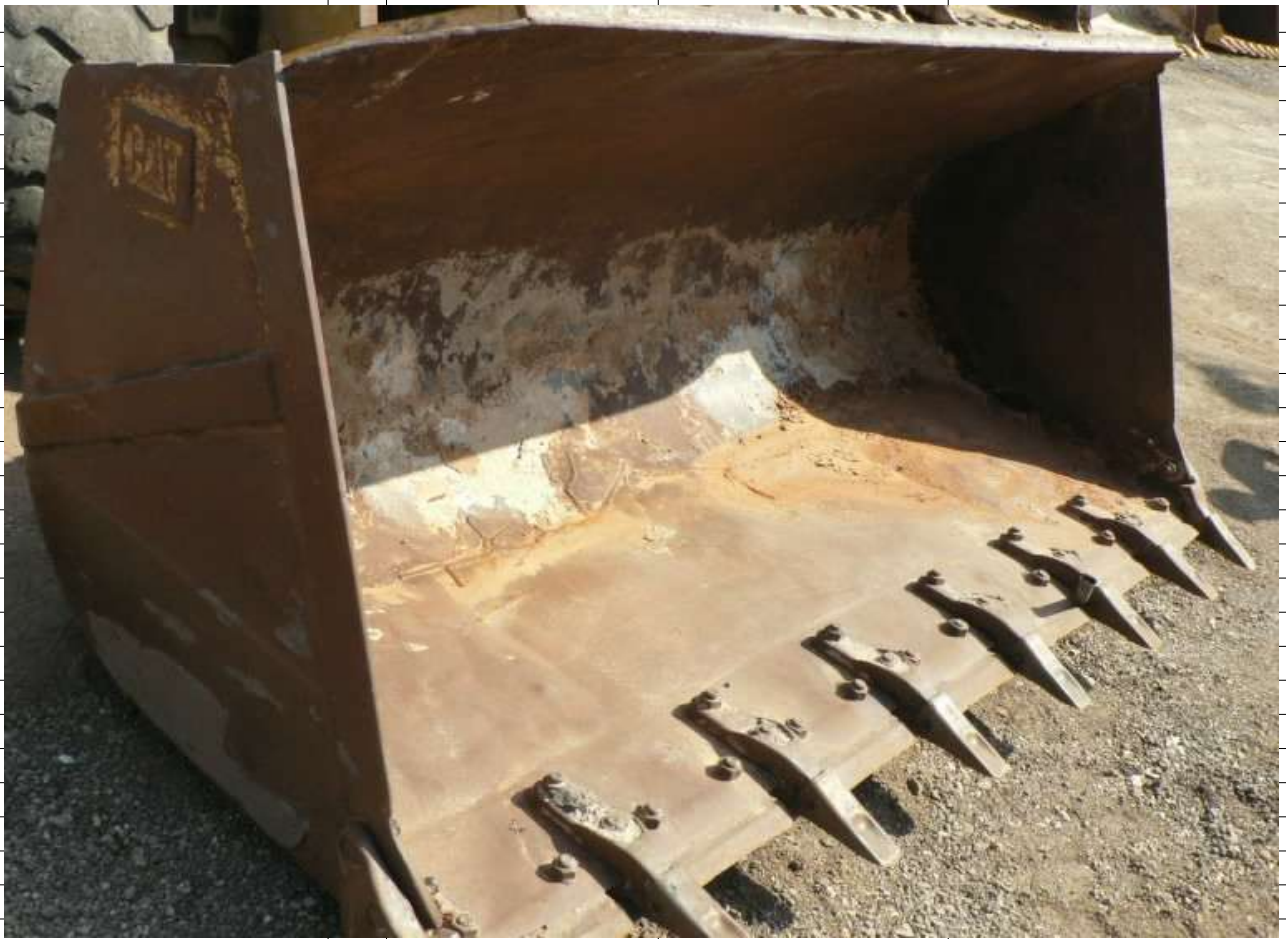
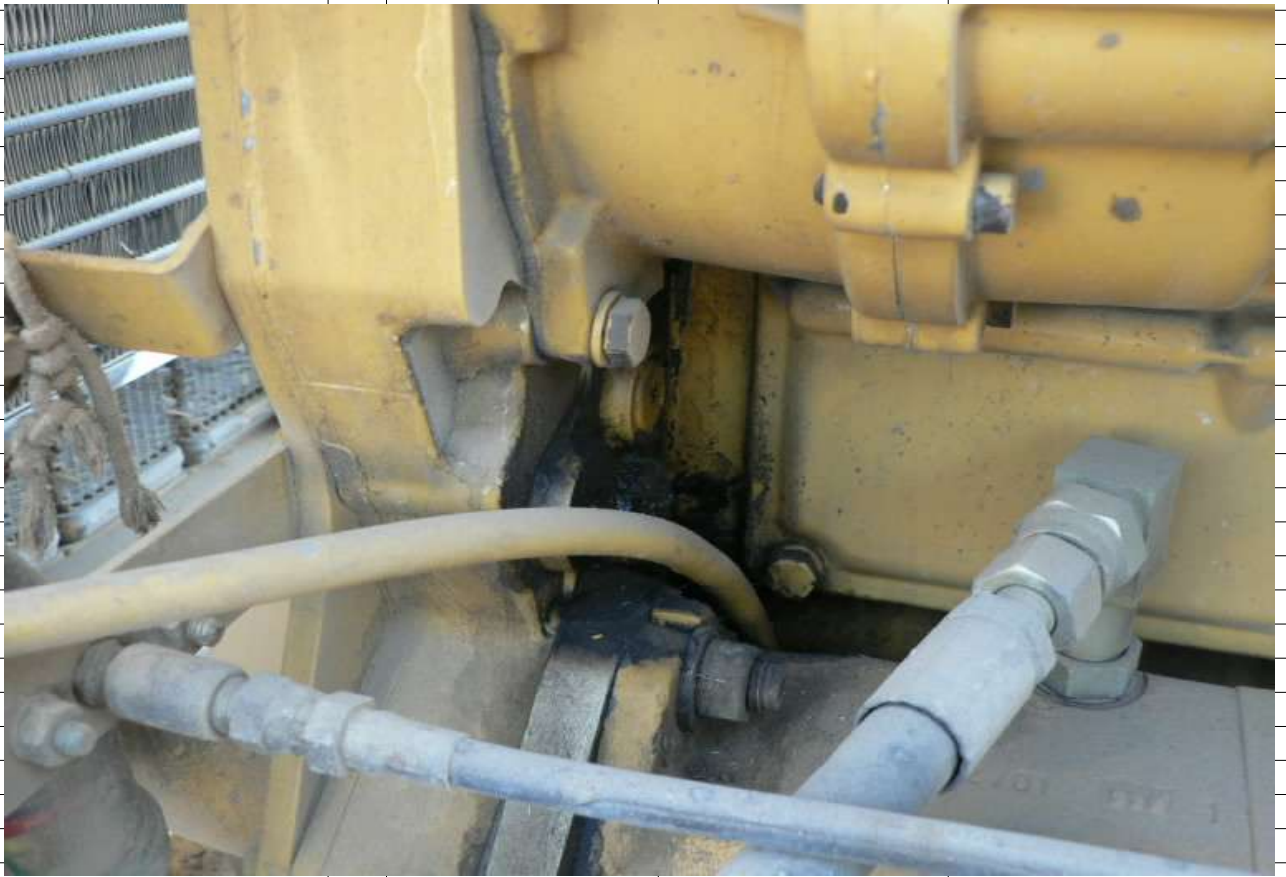
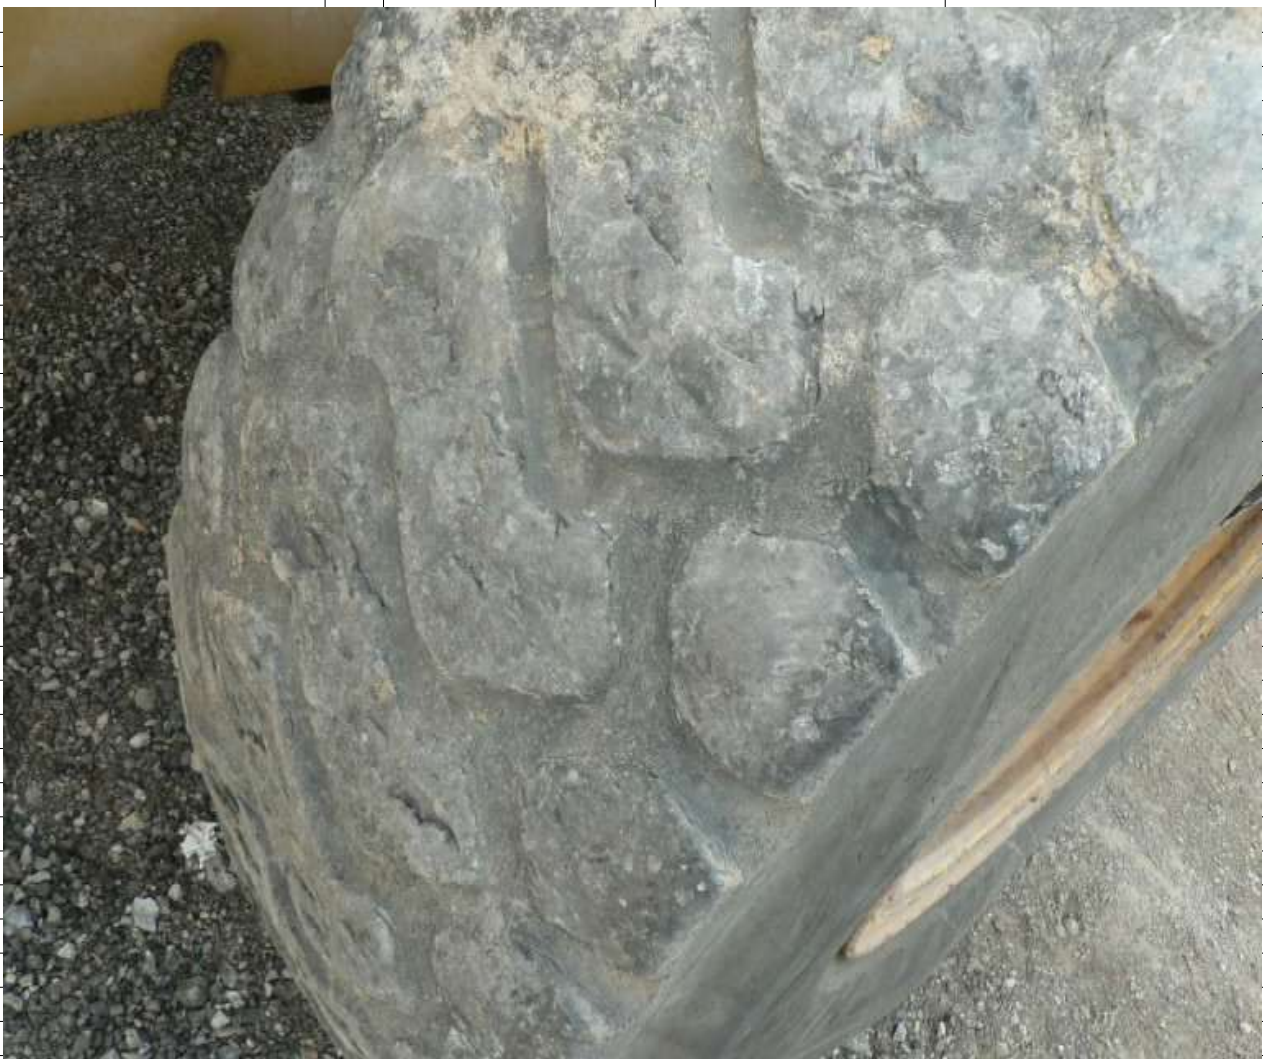
(1) engine has a small leak at hydraulic pump drive				
(2) oil is very dark and gives the impression the service is overdue				
(3) 2 front lights not working (4) paint OK for age but some corrossions at doors & frame

(5) The door is corroded and rubber seal is loose.				
The general condition is good for the hour level. Some smaller repairs are to do, the scheduled maintenance should be done. Bucket need repair before further use.				
Some cables in engine compartment are replaced by loose cable work. Should be fixed.

cab	OK			
seat		a bit dirty	windows	front window has a crack
switches		OK	wipers	OK
gauges		OK	structure	(5)
aircon / heat		working		
engine			power OK:	OK
leaks		(1)	noises	OK
oil condition		(2)	blow bye	OK for hour level
exhaust		OK	belts	to be adjusted
cooling system		OK		
visual inspection	OK			
lift frame / linkage		a bit play in pins	hydraulics	
frame		OK	hoses	OK
doors		OK	lines	OK
engine hood		crack right rear	pumps	OK, no abnormal noises
axles		OK	lift cylinder	OK
ROPS		OK	tilt cylinder	OK
lights		(3)	cylinder 4x1	N.A.
paintwork		(4)	steering cyl.	1 is leak
functional test	OK			
lift frame & pins		a bit play but no repair necessary		
bucket linkage		a bit play but no repair necessary		
transmission fwd		OK		
transmission reverse		OK		
brakes		OK holding 2 nd gear		
park brake		OK		
steering		a bit play but still OK		
tires		% remaining	size / brand	cuts
front right		40	Michelin XHA 20.5R25	no
front left		40	Michelin XHA 20.5R26	no

rear right		45	Michelin XHA 20.5R27	no
rear left		45	Michelin XHA 20.5R28	no
attachments				
bucket size: 2,7		condition:	sides, adapters and teeth OK,	
bucket floor is worn and has been welded, repairs required
